Experimental Investigation on Three Dimensional RC Infilled Frame - RC Plane Frame Interactions With Slab for Seismic Resistance

Suyamburaja Arulselvan and K.Subramanian
Coimbatore Institute of Technology, Coimbatore-641 014, Tamilnadu, India

Abstract: Experimental investigation was planned and conducted to study the influence of brick masonry infill and slab in a three-dimensional reinforced cement concrete frame. In this study, one-fifth scale 3D R.C frame representing single story, three bays with central bay brick infill at the sides and a long single bay without infill in the middle of the frame along loading direction and two numbers of two bays at the edges without infill and two numbers of single bay without infill in the transverse direction with slab, has been taken for experimental investigation and the available methods of theoretical analysis for the frames have been carried out. Totally ten columns, eight columns in both ends of the frame along loading direction and two columns in middle along loading direction, were constructed in the frame. Until the cracks developed in infills, the contribution of the infill to both lateral stiffness and strength is very signific

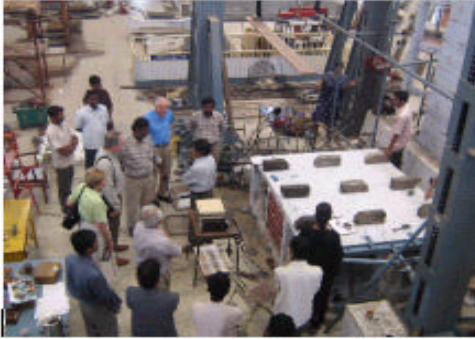
Fig.1: Model and Test set up of frame

Experimental program general: The experimental investigation consisted of testing one-fifth scale single story model of three dimensional reinforced concrete frame with two numbers of three bays with central bay brick infilled along the loading direction and two numbers of two bays without infill in the other (transverse) direction with slab under static lateral cyclic load. The columns were constructed on the raft foundation. The raft foundation made with sufficient number of circular holes to fix the frame on the test floor. The frame members are designed in such a way that plastic hinges in beams are realized before the failure of columns. The frames were cast with quality raw materials. The three dimensional RC frame model is shown in Fig.1.

Lateral cyclic loading was applied at story level in line with the beams. The reaction frame, which is used for loading arrangements, is rigidly fixed to the test floor. Hydraulic jack of capacity 200 KN were used and it will transfer by line load to the frame. Loads were applied from jack at story level of the frame. Pressure gauge was used to measure the applied load. For the application of load through jack one hand operated oil pump was used for applying load. Twelve LVDT (Linear Variable Differential Transformer) of least count 0.01 mm and nine deflectometers were used for measuring deflections at story level during the initial stages of loading.

Testing Procedure Testing of Frames: Fig.1 shows the complete test setup adopted for the frame model. The effectiveness of instrumentation set up and the loading were checked in the beginning by loading and unloading the frame with small loads (of the orders of 2.5 KN) till all the readings was repeatable. The frame was subjected to equivalent static lateral cyclic loading. The loading sequences in the beginning were almost same. The load increment for each cycle was 2.50kN at all the stages. The deflections were measured at each increment or decrement of load. The strains in steel, concrete and infill were monitored at maximum load of each cycle and at unloading conditions of frame (i.e. when the load is released fully) during all cycles of loading. The formation and propagation of cracks, hinge formation and failure pattern have been recorded. The concrete cubes were tested for 3^d, 7^h and 28th day's strength as per IS 516 - 1964. The brick prisms

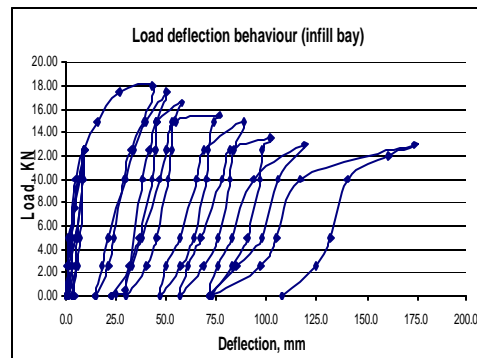
Fig. 2: Hysteretic curves of Base Shear Vs Top story Deflection of three bays with center bay infill

Load - Deflection Behavior of Infill Bay: The story deflection versus base shear diagram is presented in Fig.2. and Fig.3 From the hysteretic curve assuming bilinear behaviour, the yield deflection δ_y was found to be 9.3 mm. The curve exhibited considerable pinching (the middle part of each hysteretic loop was relatively narrow), as well as some stiffness and strength degradation during same-drift repeat cycles. This behaviour is characteristic of most RC frame connections and is typically attributed to reinforcement bond slip through the joint region, concrete cracking, and/or reinforcement yielding. At the maximum load, the deflection in experiment was 43.1 mm and in the analytical results it was 9.73 mm as shown in Fig. 4 and in the table 1. In the experiment, the reinforcement components of the frame was subjected to yielding at every cycle. This was cause for high energy set up in the frame. Also this was the one of the reason to maximum deflection in the frame.

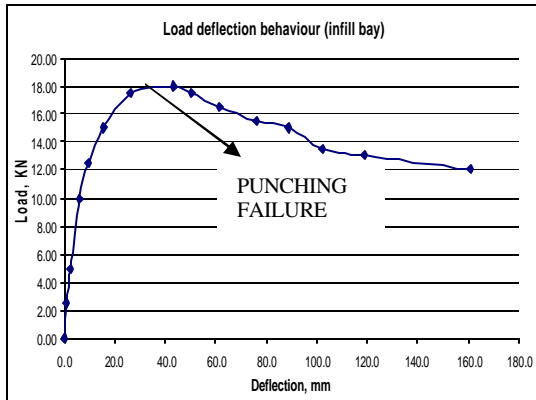
Fig.3: Base shear vs Deflection

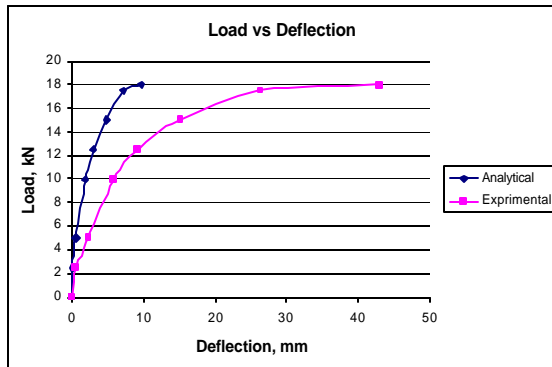
Fig.4: Base shear vs Deflection

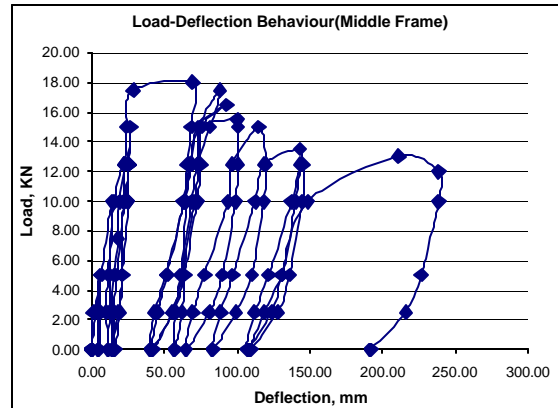
Fig. 5: Hysteretic curves of Base Shear Vs Top Storey Deflection

Load - Deflection Behavior of Middle Plain Bay: The variation of maximum story deflection with respect to applied lateral load (Base Shear) is presented in Fig. 5 and Fig. 6. The punching shear failure of the frame is indicated in Fig. 6 by sudden drop in lateral load capacity during 7th cycle. At the maximum load, the frame was obtained distinguish deflection and higher energy was stored in this cycle than the previous cycles. This may be due to expansion and propagation of micro cracks formed in the frame and the failure of infill and

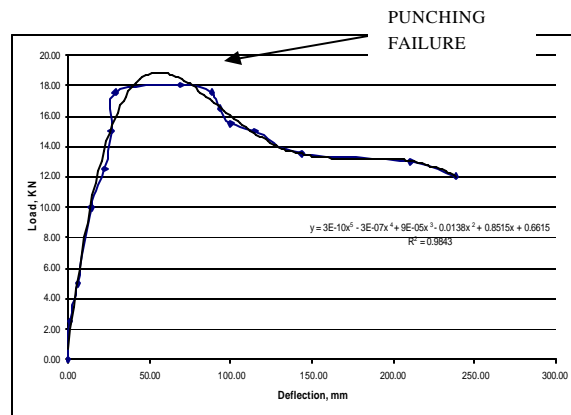
Fig.6: Base shear vs Deflection

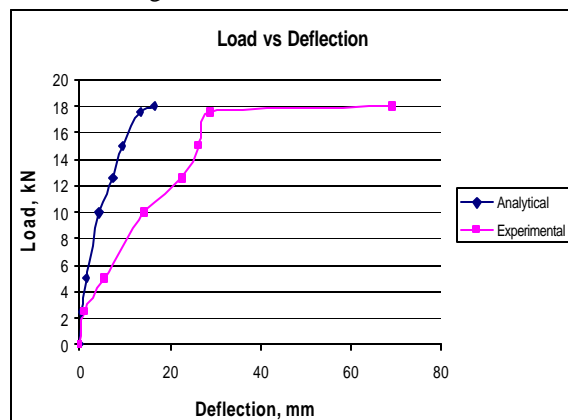
Fig.7: Base shear vs Deflection of middle plain bay

starting of failure of whole 3D frame. At the maximum load, the deflection in experiment was 69.4 mm and in the analytical results it was 16.59 mm as shown in Fig. 7 and in the table 2. Yielding and bond failure were one of the reasons for this difference in deflection.

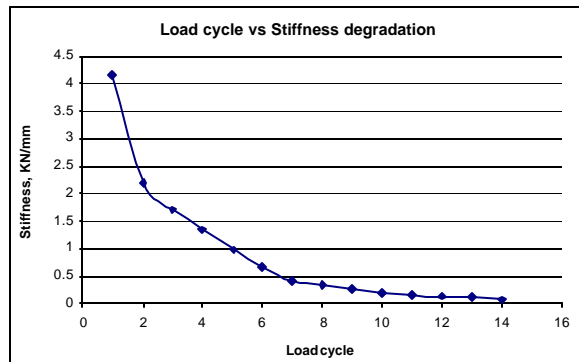
Fig.8: Load cycles-stiffness degradation

Three Bays With Central Bay Infill: Stiffness degradation was faster in the first cycle, it was at moderate range from second cycle to seventh cycle and after seventh cycle it was minimum. The stiffness was 1.8 percent of maximum in the last cycle. There was a sudden change in the stiffness curve after seventh cycle. At seventh cycle, the frame was start to failure and the bond between the concrete and steel was collapsed. This was one of the reason of the stiffness reduction in this frame. The stiffness graph is shown in is shown in Fig.8

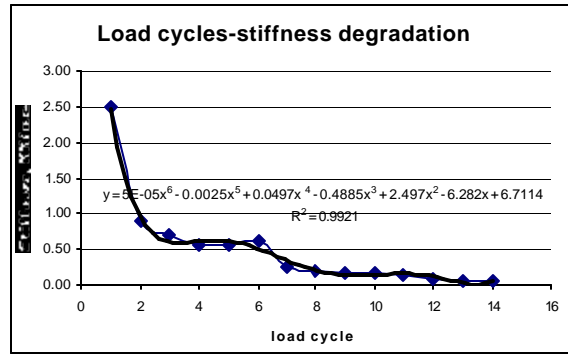
Fig.9: Load cycles-stiffness degradation

Middle Single Bay Without Infill: The stiffness of the middle plain frame for various load cycles were calculated and presented in Table3 and the variation of stiffness with respect to load cycles is shown in Fig.9. The theoretical maximum stiffness, the experimentally observed stiffness at cracking load and stiffness at service load are also found out. The stiffness of the brick infilled R.C. frame was found to decrease from 2.5 KN / mm during first cycle to 0.0503 KN/ mm during the thirteenth (final) cycle of loading.

Stiffness was in the decreasing order in the consecutive cycles. The trend line equation of the stiffness degradation curve was indicated in the graph

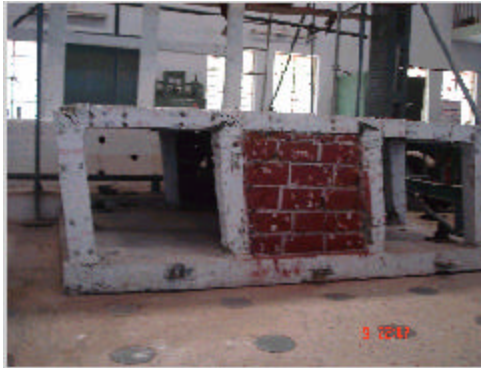
Fig. 10: Cracks and deflected shape of full frame

Load Carrying Capacity: Separation cracks were first noticed in the interface between brick infill and beam in the fourth cycle. In the fifth cycle, separation cracks and foundation-column cracks and brick infill failure were found. The maximum load applied on the frame was 18.0 kN. Distinguish difference in deflection was obtained in the maximum load from the loads from starting. The different types of cracks witnessed during various loading stages are shown in Fig.10 to Fig.12

Behavior and Failure Modes: The first crack was witnessed in the interface between brick infill and beam when the base shear was 12.5 KN. The cracking occurred during loading reflect the fact that the infilled frame behaved as an integral unit. At failure, the infilled frame exhibited spalling of brick fragments. The formation of plastic hinges in the beam-column joints observed after severe cracking of brickwork. The leeward shear also presented in addition to compression because of the diagonal strut effect of the infill. At the junction of the diagonal strut, leeward column and foundation, the leeward column suffered shear and local buckling. This initiated the final collapse. However separation cracks between frame and infill occurred in all stories panels. The failures occurred in the beam-column joints and in the interface between beam-brick infill. Minute line cracks were found in the slab. The three dimensional RC infilled frame at failure stage is shown in Fig. 10 to 12.

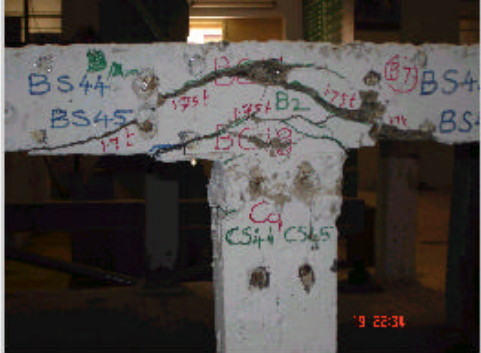
Fig 11: Typical Beams-Column Joint crack in the single long bay

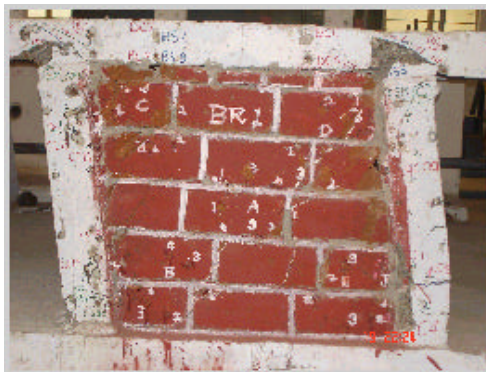
Fig 12: Cracks in infill panel and shear buckling of windward column
