Original Research Paper

Predictive Dynamics of Channel Pattern Changing Trends at Arial Khan River (1977-2018), Bangladesh

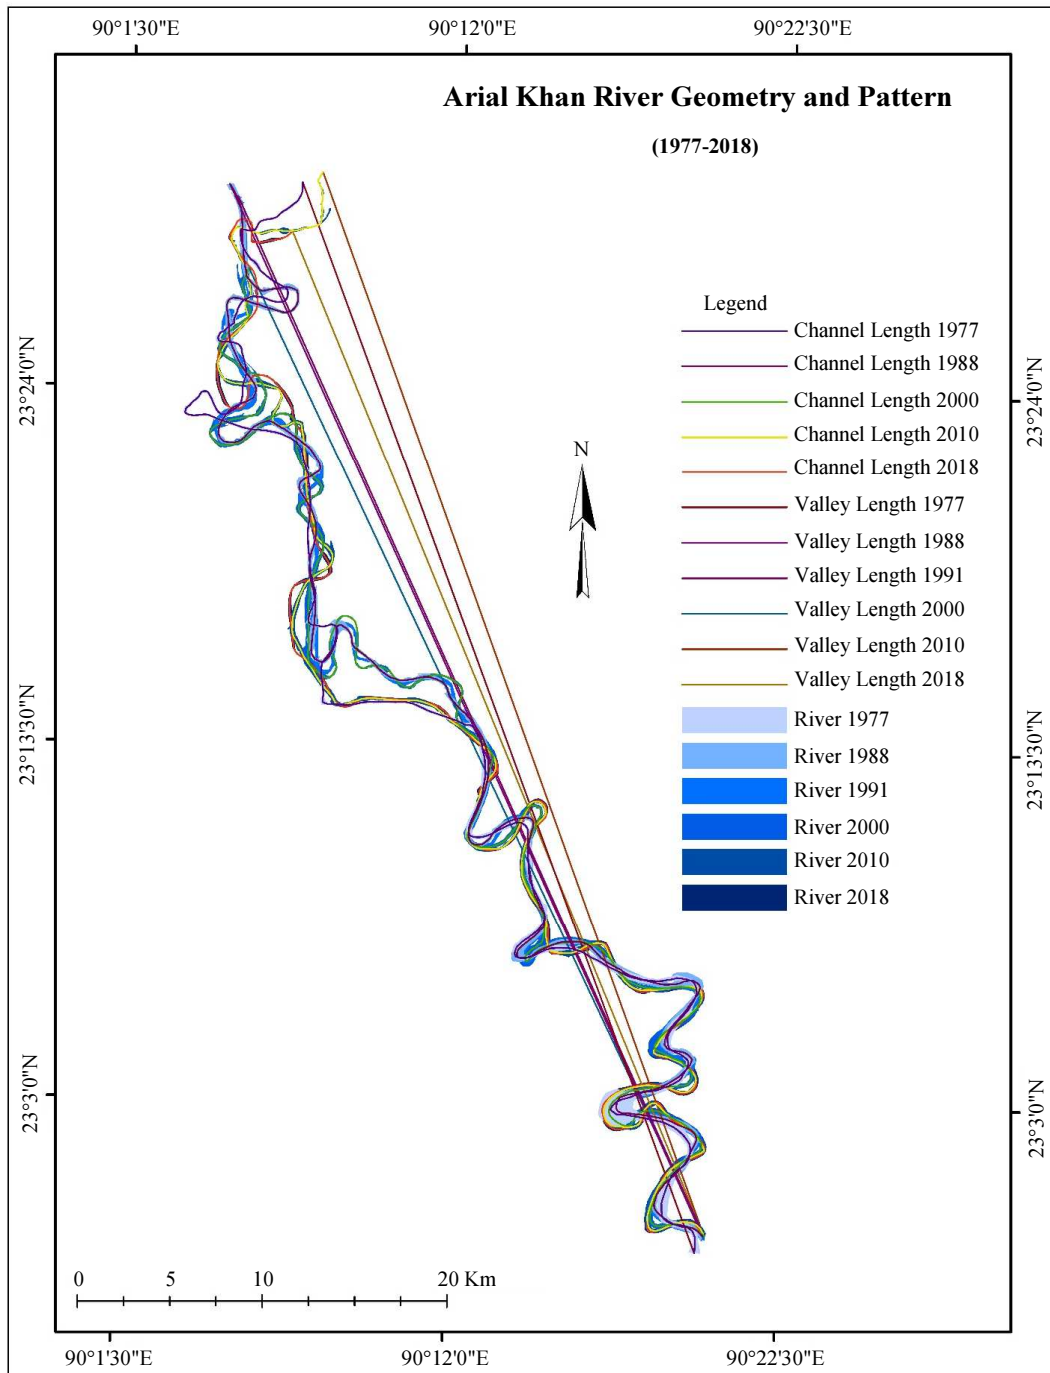
Fig. 3: Channel length, valley length and sinuosity ratio of Arial Khan River (1977-2018)

with Padma River due to right bank erosion of Padma. It results variation in length, valley length and sinuosity ratio (Fig. 3). From Table 1, the study reveals that the length of Arial Khan River in the study area is increased 105.58 km in 1977 to 110.85 km in 2018. On the other hand, the valley length was decreased 62.0789 km in 1977 to 59.0795 km in 2018.

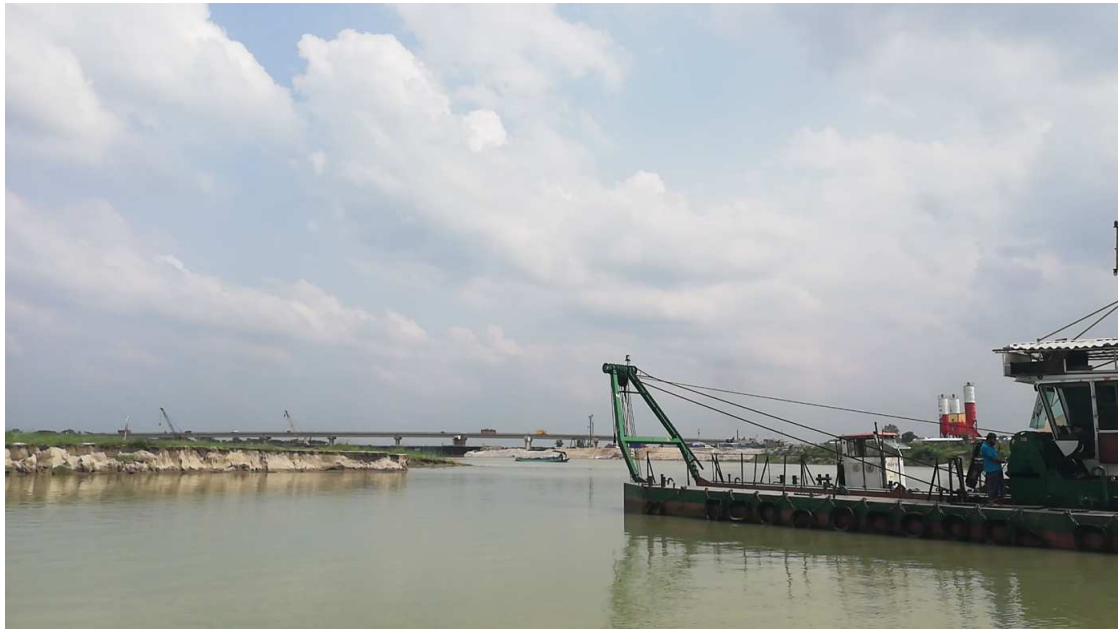
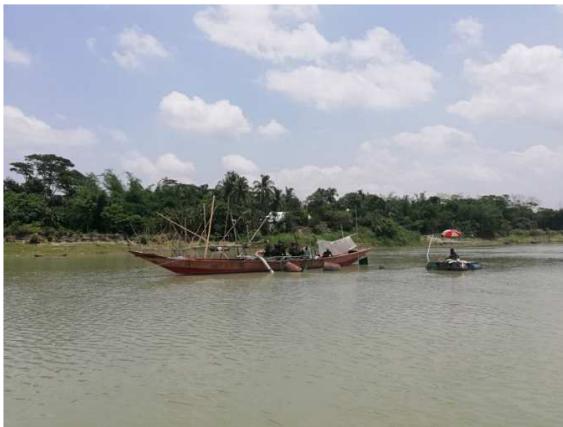
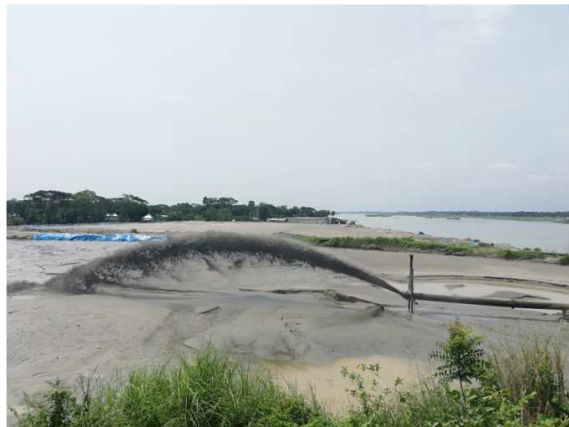
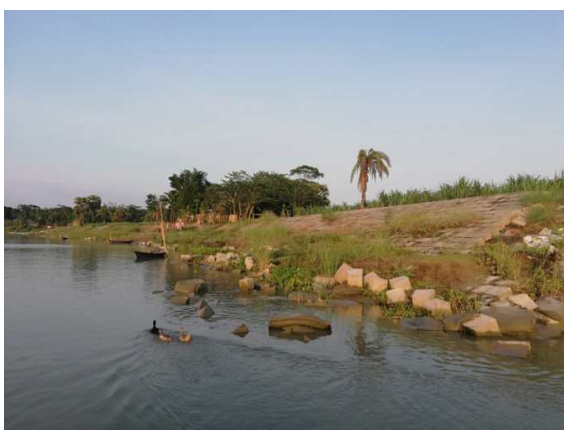
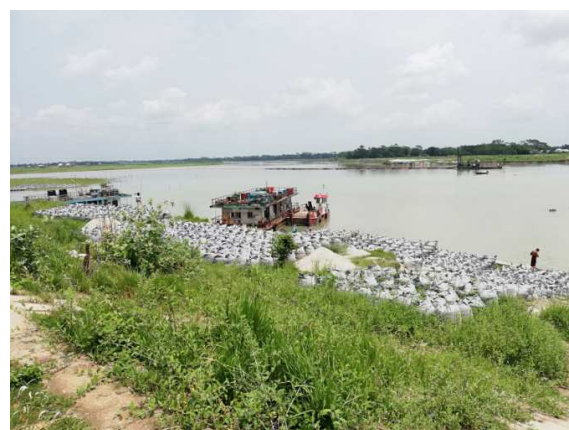
Fig. 5: Barrier and river management strategies; (a) Construction of Haji Shariaullah bridge over Ariakhan river, (b) Sand dredging from river for business purposes, (c) River aggression through dredging, (d) Embankment construction to protect river bank and (e) Storage of Geo-textile bags for use

River navigability is falling. Once huge amount of fishes were found, now people are forced to farm fish for their livelihood. Currently Arial Khan River is flowing straight by splitting bar (charland) after the construction of Haji Shariatullah Bridge. Some victims of river erosion migrated themselves to cities including capital.

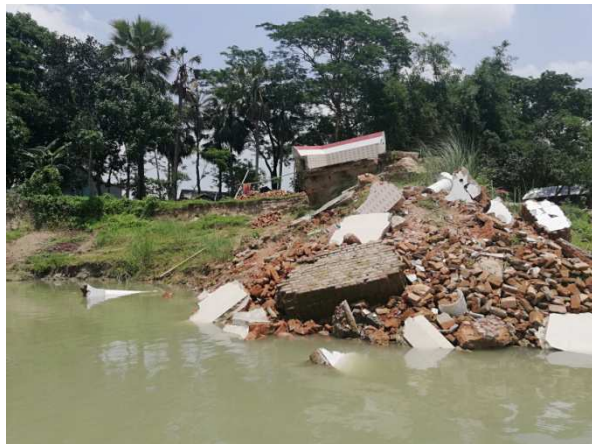
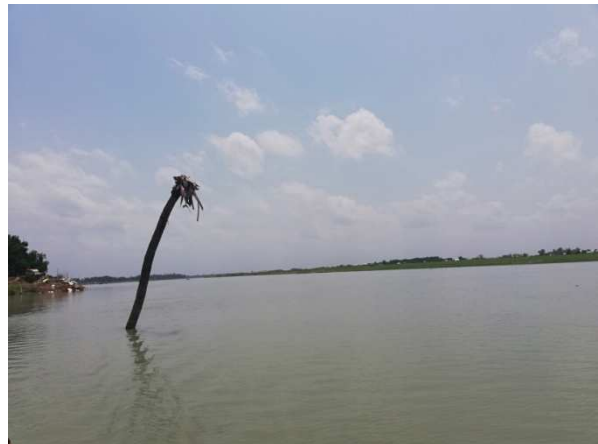
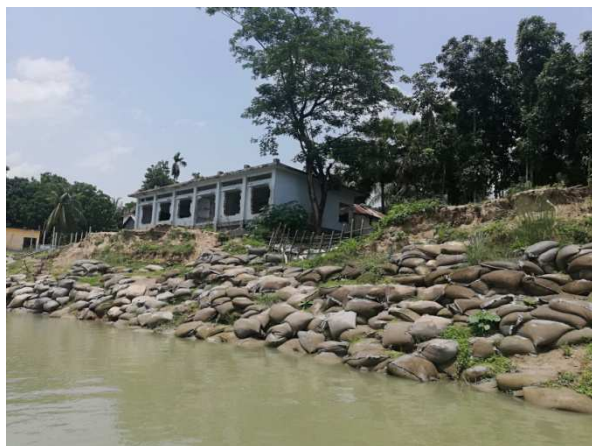
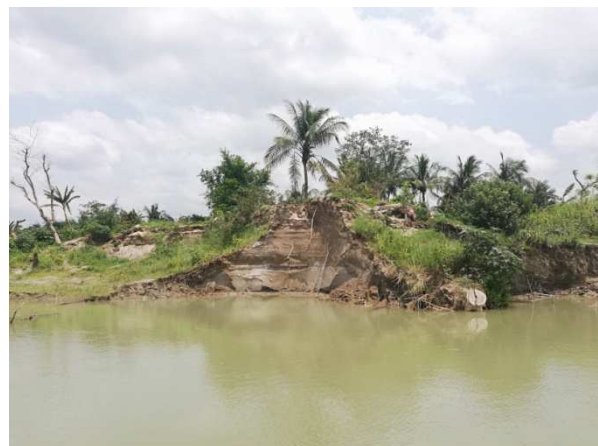
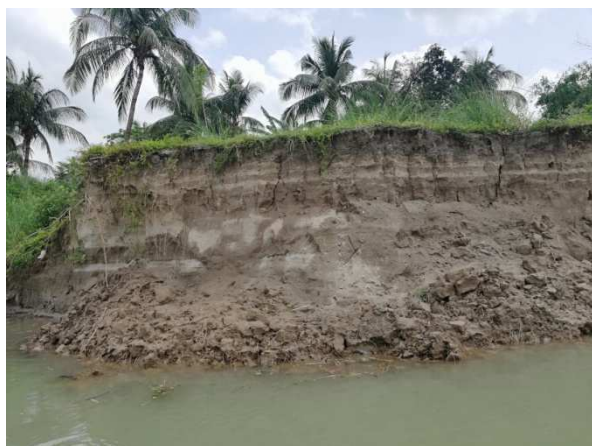
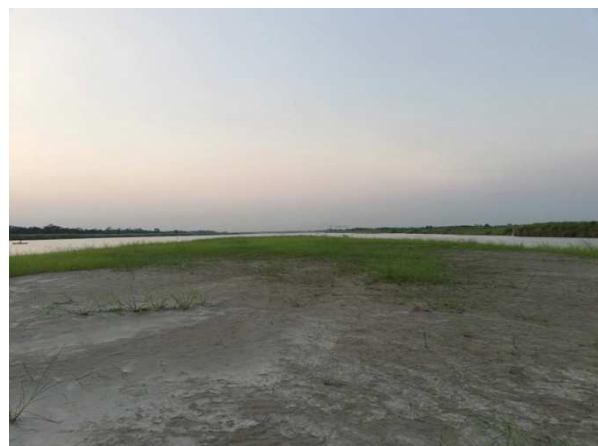
Fig. 6: Morphological responses of Arial Khan River; (a) Structural destruction by river bank erosion, (b) Settlement with homestead vegetation washed away into river, (c) Educational institution are in risk, (d) Vulnerable settlement and homestead vegetation, (e) Mainland floodplain and soil erosion and f) Sandy barland development by sediment deposition

development are vulnerable along the river side (Fig. 6a to 6e). A farmer from Bhatirchar village of Madaripur district, commented that:

Morphological changes of Arial Khan River impacts on navigability, aquatic fish resources and bar development (Fig. 6f). A young educated boy's from Utrail of Madaripur district mentioned the impacts of morphological changes by following statement:
