In-Plane Behavior of Infills using Glass Fiber Shear Connectors in Textile Reinforced Mortar (TRM) Technique

Keywords: Masonry Infill, In-plane, Strengthening, TRM, Shear Connectors

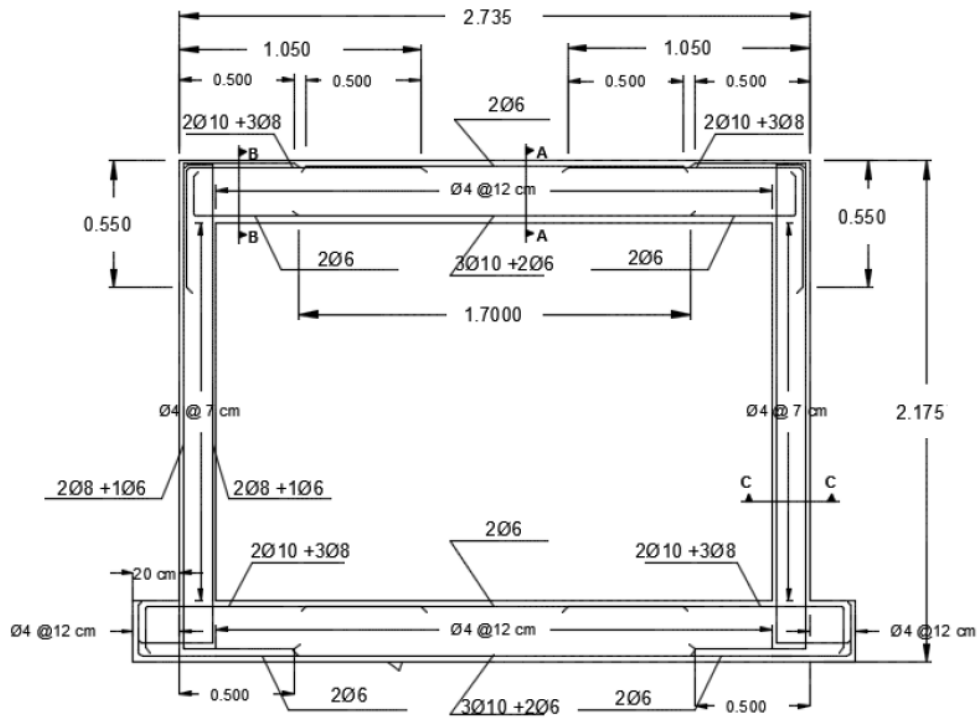
Fig. 1: Geometry and reinforcement scheme of the reduced scale rc frame (dimensions in meter)

An overview of the scaled reinforcement scheme of the rc frame and of the cross sections of columns and beams are shown in Fig. 1 and 2.

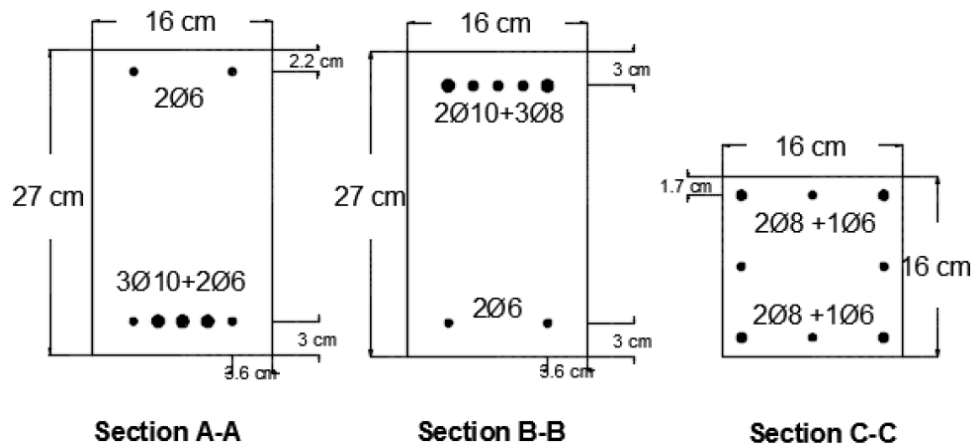
Fig. 2: Cross-sections of columns and beams in reduced scale rc frames

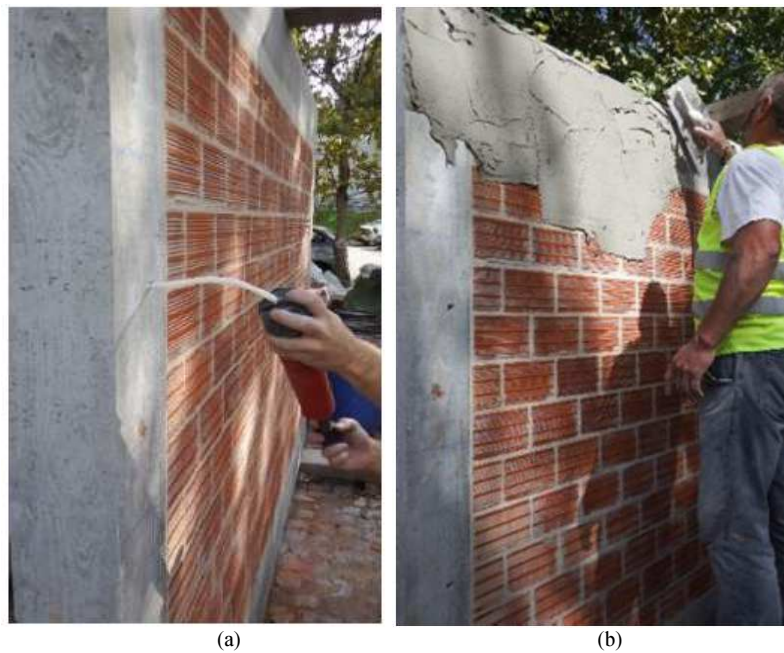
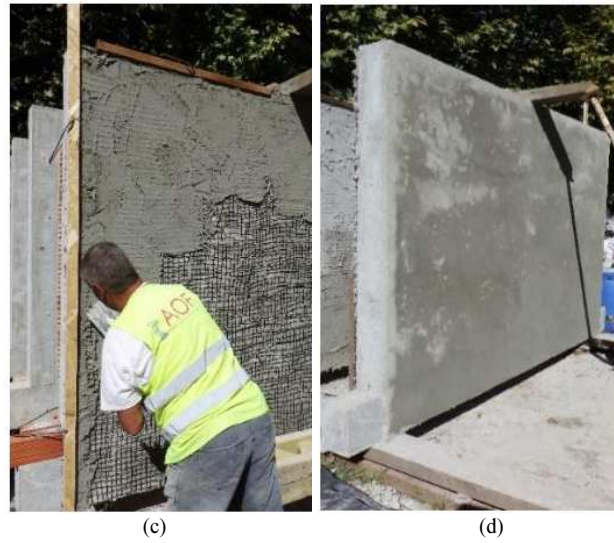
Fig. 5: Application of the reinforced rendering; (a) drilling the pilot holes (b) applying the first layer of mortar (c) positioning of the textile mesh and application of the second layer of mortar; (d) final aspect after rendering

Additionally, L-shaped shear connectors were used to avoid any detachment of the rendering mortar from rc frame and masonry infill (Fig. 4a). Following steps were used to apply the rendering mortar to the specimens: In the first step the pilot holes were defined as shown in (Fig. 4a) to place the shear connectors in the specimens. In the second phase the holes were drilled and cleaned and then the plastic row plugs shown in Fig. 4b were inserted in the holes (Fig. 5a). In the third step, First thin layer of about 5 mm of mortar was applied on the specimens (Fig. 5b). In the fourth step, chemical anchor was injected into the holes and L-shaped glass fiber connectors were inserted into them. Then in the fifth step the textile mesh was positioned on the first layer of mortar and finally in the last step the second layer of mortar was applied and rectified, see (Fig. 5c and d). The total thickness of the rendering was measured as approximately 20 mm in all the specimens. The application of the rendering in two successive layers enables the involvement of the textile mesh by the mortar and also adequate development of the adherence between them.

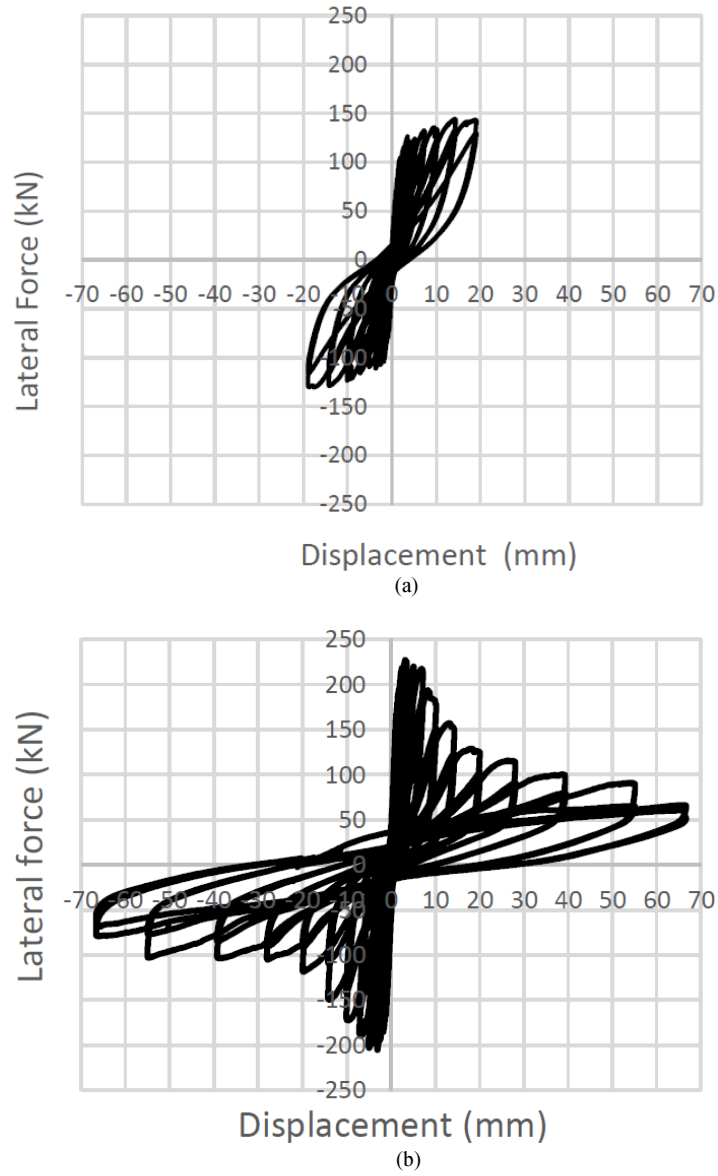
Fig. 10: Force-displacement diagram; (a) SIF-I(1%) (b) SIF(DTRM)-I

The lateral force-displacement diagrams obtained for unstrengthened and strengthened specimens are shown in Fig. 10. It is clear that the strengthened specimen demonstrates better response in terms of initial stiffness and lateral strength. The increase in initial stiffness and lateral strength was reported as 43 and 58% in positive direction and 23 and 57% in negative direction. As it was mentioned previously, the unstrengthened specimen was tested until lateral drift of 1% to be used in another testing campaign investigating the effect of prior in-plane damage on out-of-plane response. The positive direction is considered as the direction that the hydraulic actuator pushes the specimen whereas the negative direction is considered as the direction that the actuator pulls the specimen through two plates that were connected with two thick steel rods. The force-displacement diagrams are characterized by an initial linear behavior corresponding to the elastic behavior of the structure. After the onset of cracking, the nonlinear behavior is visible both through the nonlinearity of the force-displacement envelop and through the higher hysteresis corresponding to the development of damage and dissipation of energy.

The post-peak behavior is characterized by a progressive but smooth reduction on the lateral strength and stiffness, meaning that the damage is controlled and progressive.

It is clear that the strengthened specimen demonstrates better response in terms of initial stiffness and lateral strength. The increase in initial stiffness and lateral strength was reported as 43 and 58% in positive direction and 23 and 57% in negative direction.

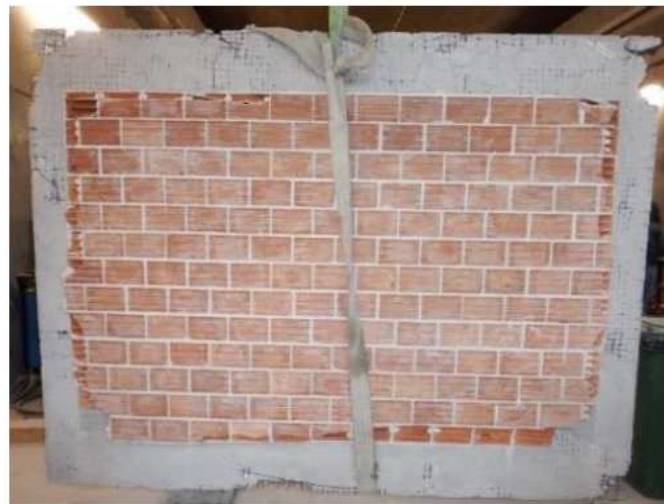
Fig. 14: View of the crushing of bricks of the infill after removing some parts of the retrofitting layer in specimen SIF(DTRM)-I

After the test, the reinforced mortar layer was removed mechanically to obtain information about the damage of the brick infill. It was seen that the masonry units crushed along the rc frame-infill interfaces, Fig. 14.

This could be related to the higher concentration of compressive stresses along the edge of the brick infill. It was also seen that no additional cracks were formed in the brick infill apart from the crushing in the bricks adjacent to the rc frame, indicating that the reinforced mortar layer acts as a damage controller by limiting the development of cracks in the brick infill. The crushing of the bricks along the interface is very similar between both strengthened specimens, even if it appears to be more significant in the specimen strengthened with the commercial textile mesh.
